# Parametric analysis of groundshock loading on steel plates and reinforced concrete slabs

Thesis submitted to the University of Sheffield  
for the degree of Doctor of Philosophy

**University of Sheffield**  
**Department of Civil and Structural**  
**Engineering**

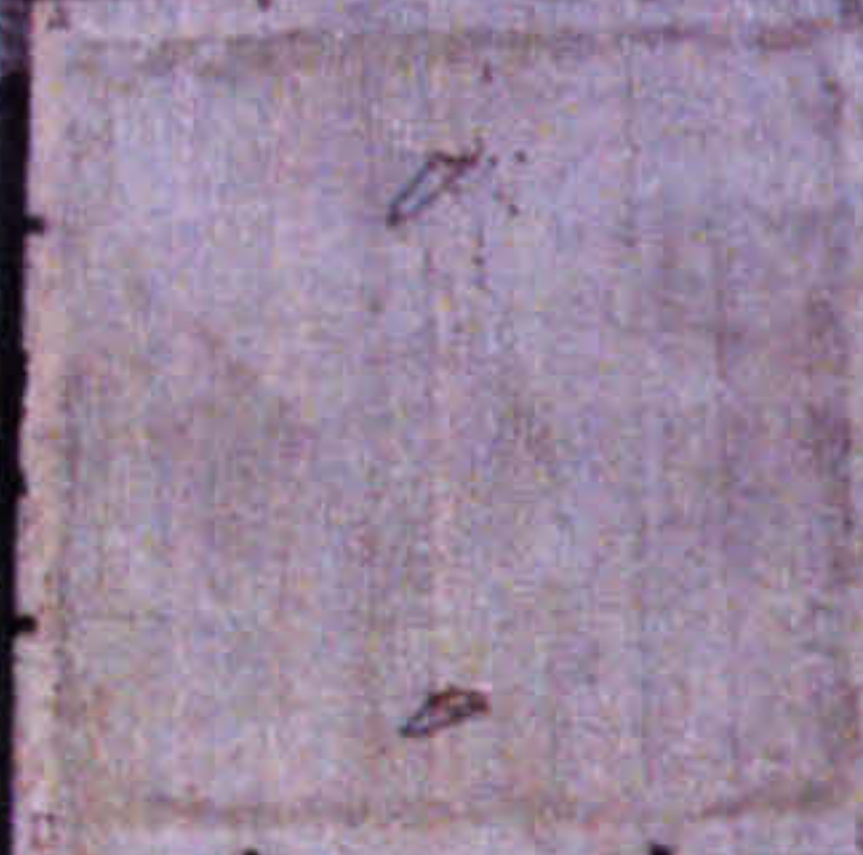
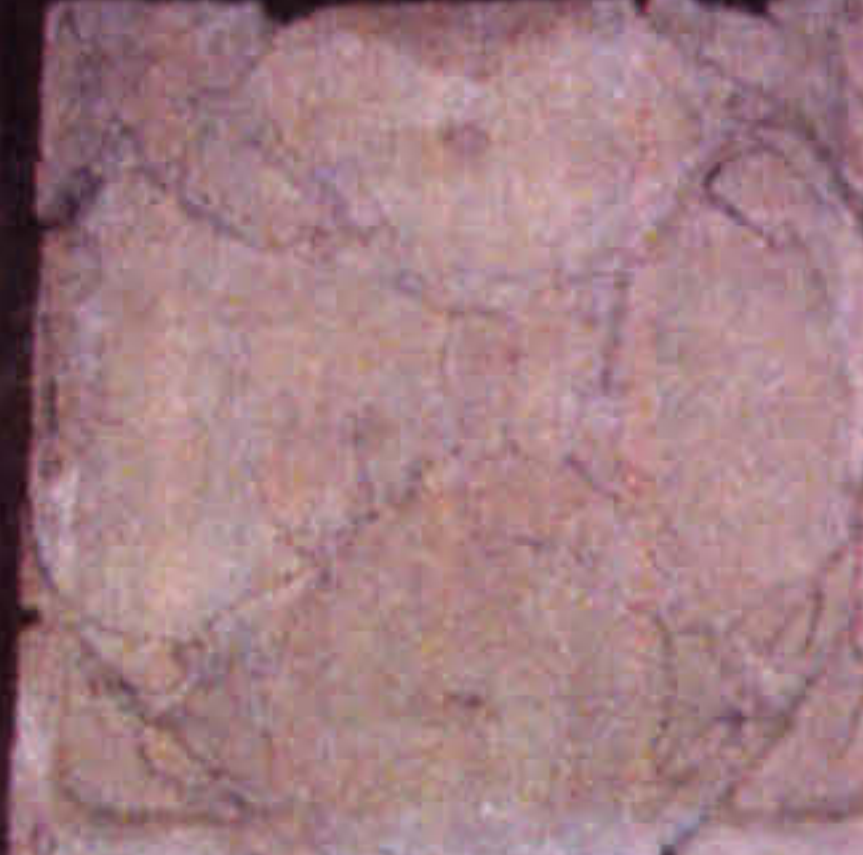
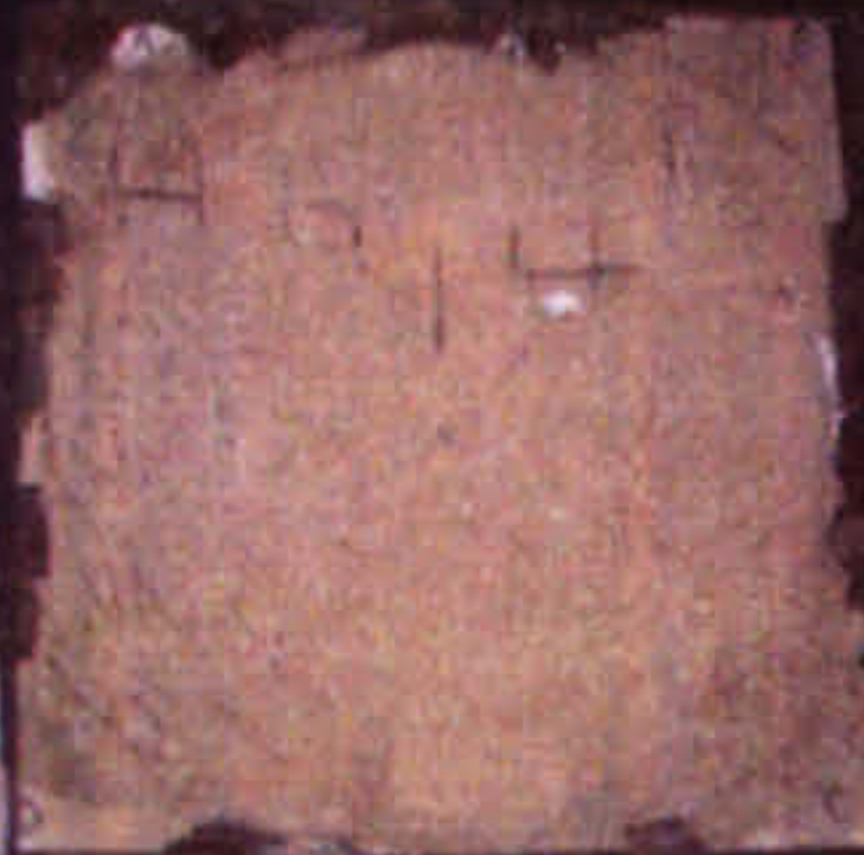
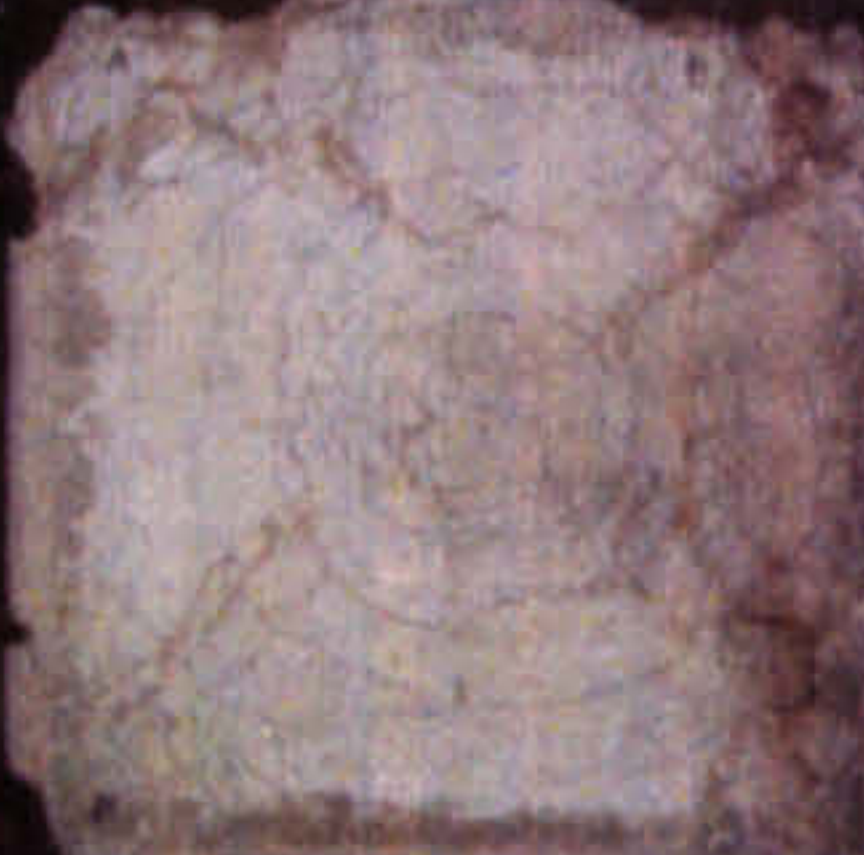
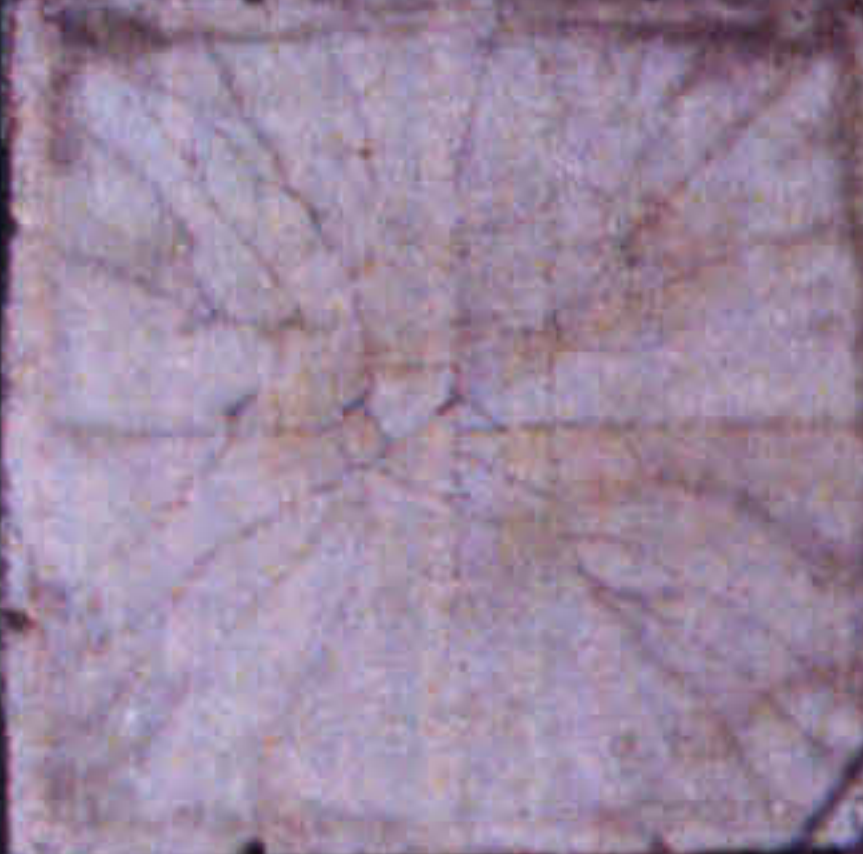
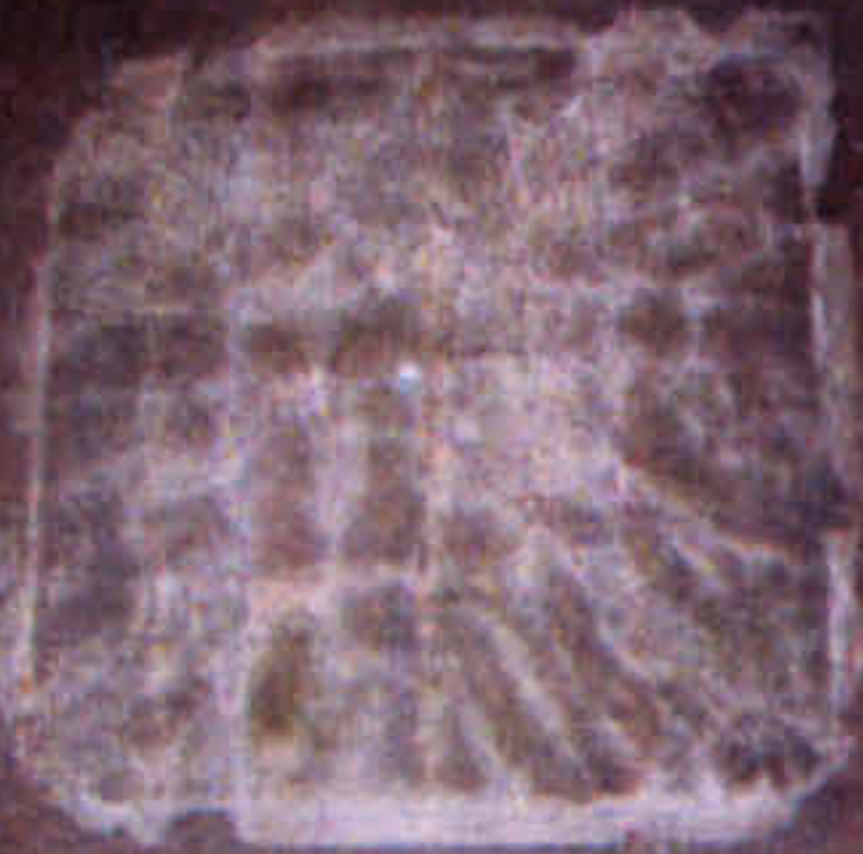
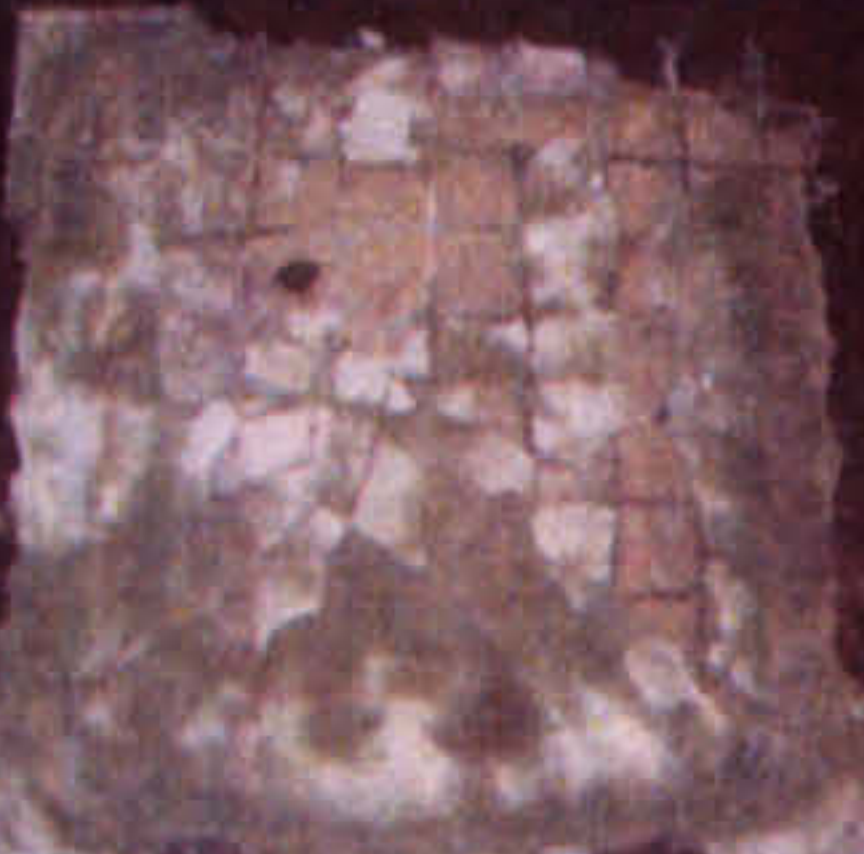
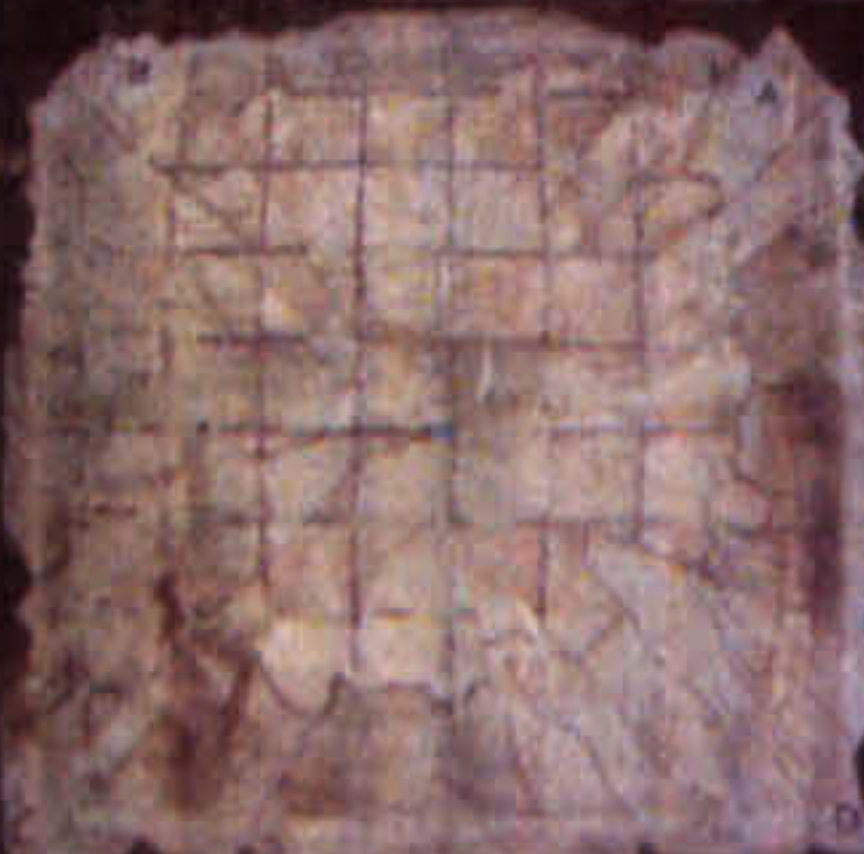
**Table 5.4.2 Cumulative damage inflicted upon the primary slabs in Stage I**

Group 1 tests	Group 2 tests	Group 3 tests	Group 4 tests
Top face

Bottom face

Slab	RCR73IT1-4	RCR73IT5-8	RCR73IT9-11	RCR73IT12-13
$Z_1$ (mm)	500mm	300mm	150mm	75mm
$Z_2$ (mm)	500mm	500mm	500mm	500mm
Cumulative hits	4	4	3	2
Charge standoffs (mm)	540,440,350,300	340,240,150,100	190,90,0	113,13
Central impulse histories (kPa-s)	1.3, 7.3, 8.1, 9.8	2.6, 8.4, 10.3, 15.5		
Magnitude of the central cumulative impulse history (kPa-s)	26.5	36.8	>45.5	*

$Z_1$  = Soil overburden contained between the primary and secondary slabs

It was evident from the damaged primary slabs in table 5.4.2 that a decrease in the charge standoff, soil overburden and the number of cumulative hits, increases the severity of damage to a primary slab. The damaged primary slabs from Stage I all illustrated a sequence of yield line mechanisms that dictated the damage mode. These were caused by an increase in the magnitude of load, which decreased spatially upon the top face at smaller charge standoffs.

The damage to each of the primary slabs has been associated with the cumulative impulse history corresponding to the sum of induced loads, sustained during the cumulative attack.

An impulsive response was only associated with slab RCR73IT1-4. It was likely that slabs RCR73IT5-8, RCR73IT9-11 and RCR73IT12-13 responded dynamically. This was not proven due to a lack of data. A measurement of impulse defined as the cumulative impulse history was associated with final degree of damage to all four slabs, as illustrated in figure 5.4.2.

The increase in damage from slab RCR73IT1-4 to slab RCR73IT5-8 was associated with a central cumulative impulse history difference of 10kPa-s (36.8-26.5kPa-s).

The central cumulative impulse history was not established for slab RCR73IT9-11 and has not been indicated in table 5.4.2. However, the predicated central impulse would have been >45.5kPa-s. The increase in damage from slab RCR73IT5-8 to slab RCR73IT9-11 was associated with an increase in the cumulative impulse history >10kPa-s (45.5-36.8kPa-s). The exact value was unknown.

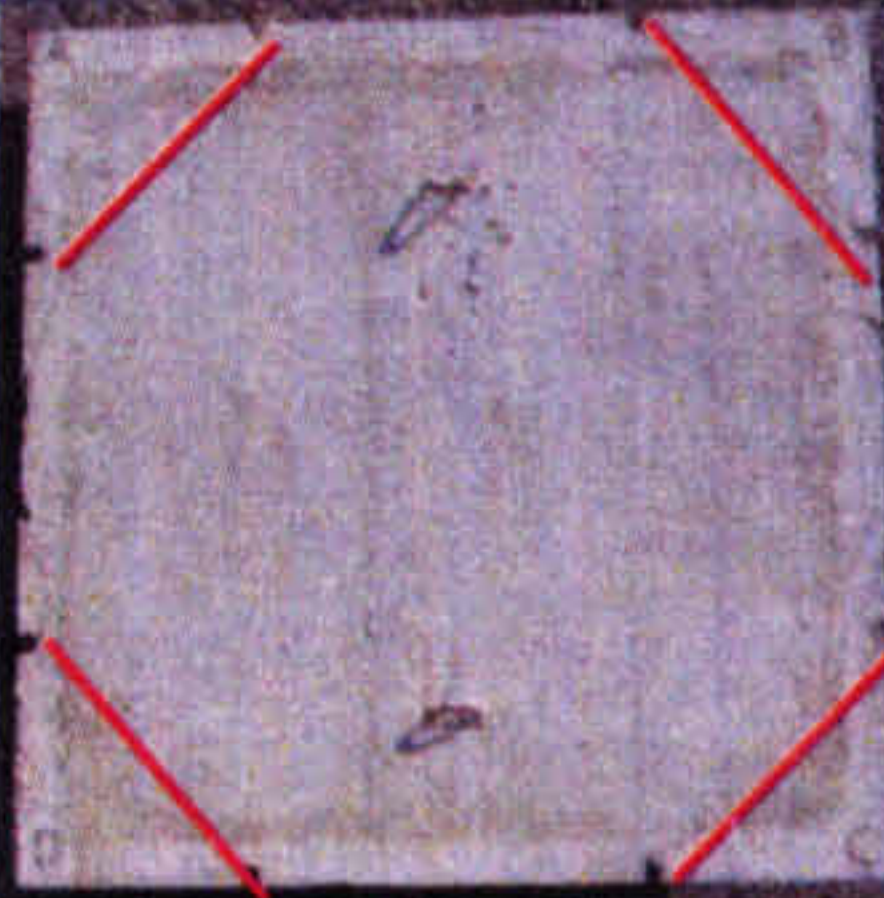
Table 5.4.3 Simplistic crack patterns inflicted upon the primary slabs in Stage I.

Group 1 tests	Group 2 tests	Group 4 tests
Top face

Slab	RCR73IT1-4	RCR73IT5-8	RCR73IT12-13
Chronological order of crack developments	1. Corner cracks	1. Corner cracks & spalling 2. Diagonal cracks 3. Central square cracking	1. Corner cracks and spalling 2. Diagonal cracks and spalling 3. Central circumferential cracking 4. Discontinuous circumferential cracking within the four quadrants
Cumulative hits	4	4	2
Charge standoffs (mm)	540,440,350,300	340,240,150,100	113,13

- 1. corner cracks,
- 2. diagonal cracks,
- 3. central square crack – Region occupied within a plastic hinge,
- 4. central circumferential crack – Region occupied within a plastic hinge,
- 5. discontinuous circumferential cracks.
